# KHE SANH

## *ANALYSIS OF ENEMY POSITIONS AND EVALUATION OF THE EFFECTIVENESS OF WEAPONS SYSTEMS AGAINST ENEMY FORTIFICATIONS*

## LESSONS LEARNED NO. 69

SUBJECT: Vietnam Lessons Learned No. 69: Analysis of Enemy Positions  
at Khe Sanh and Evaluation of the Effectiveness of Weapons  
Systems Against Enemy Fortifications

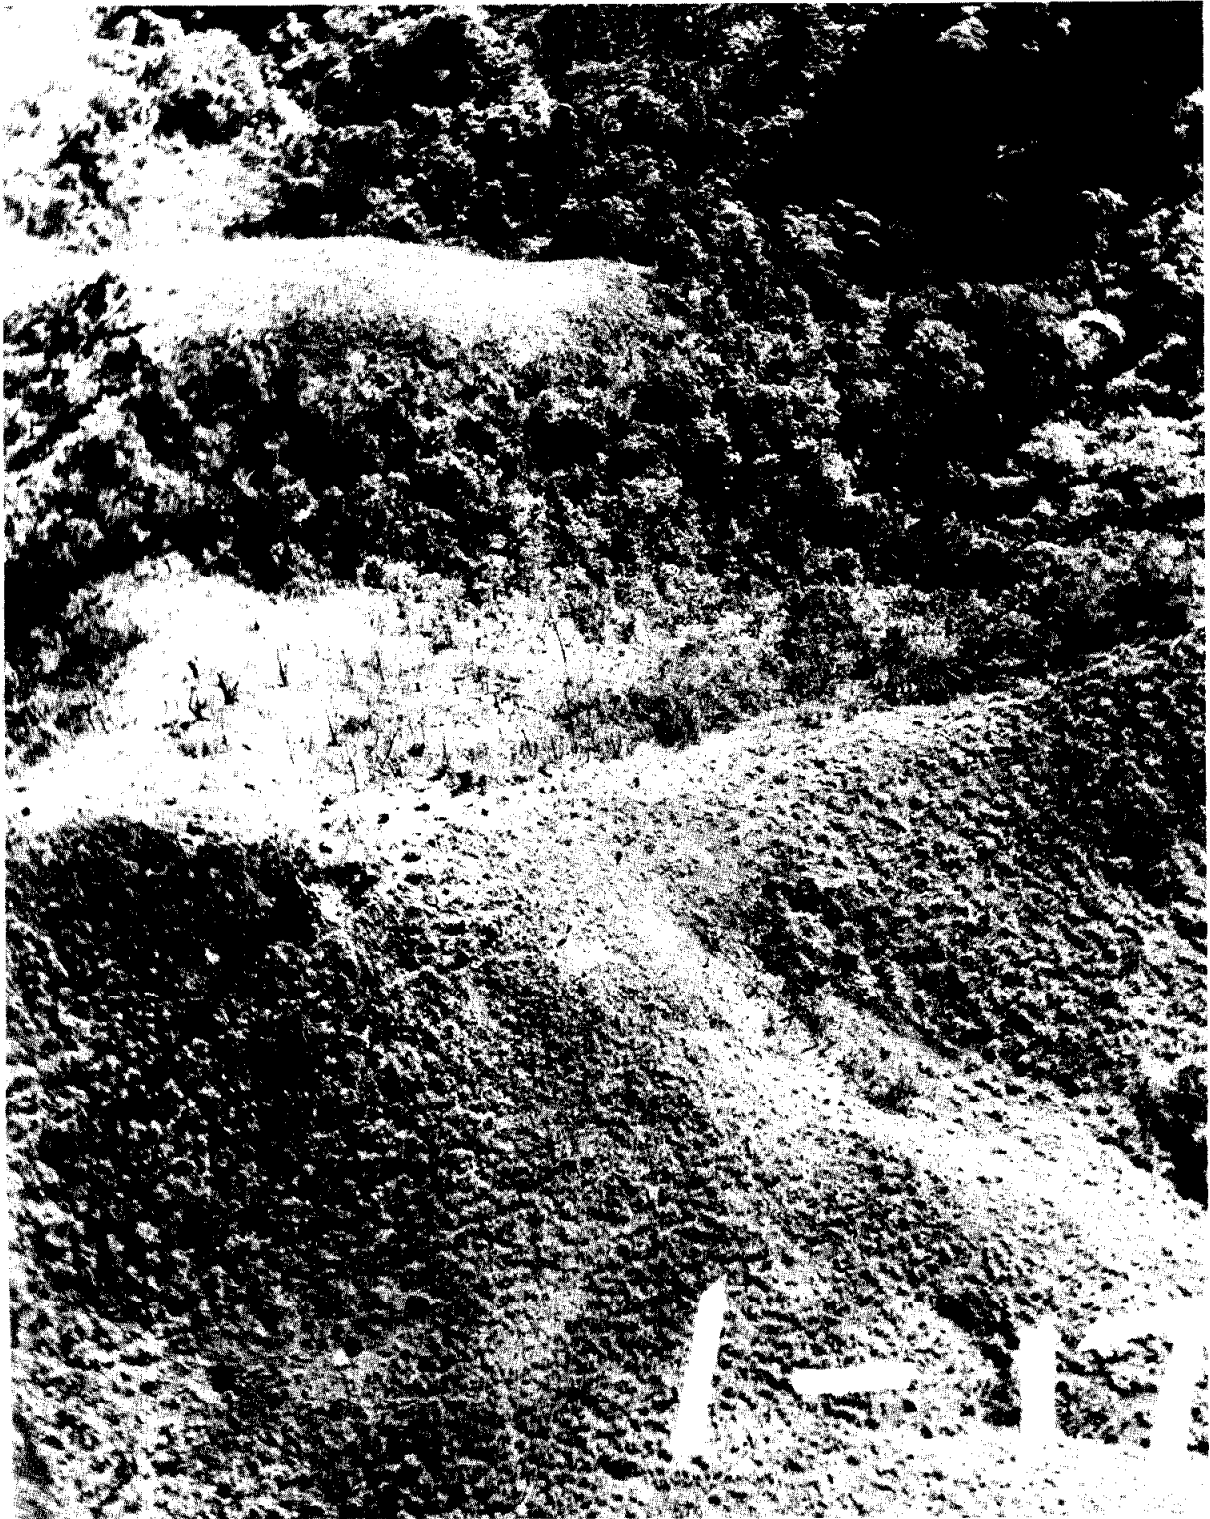
D-1 Defensive Positions

**DESCRIPTION:** NVA defensive position on Hill 663 and  
damage caused by airstrikes and artillery

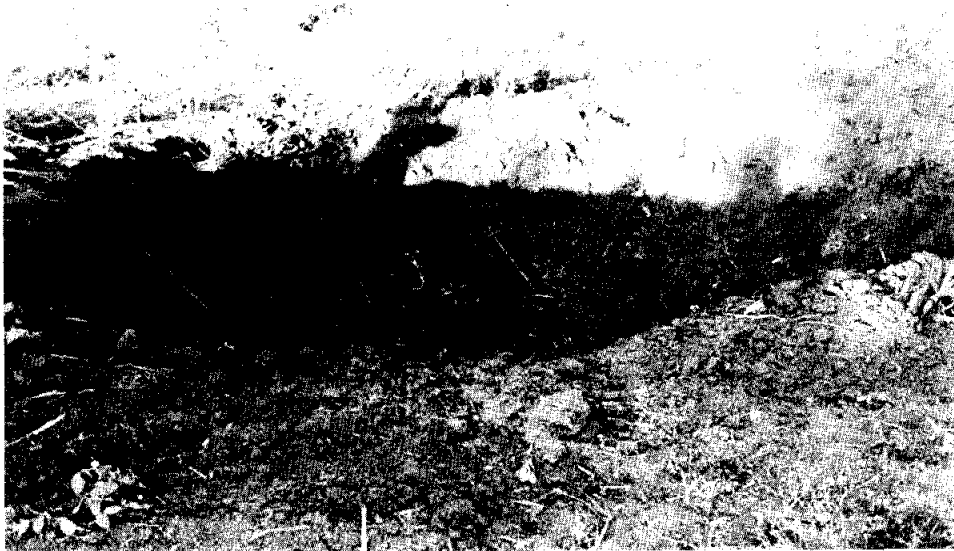
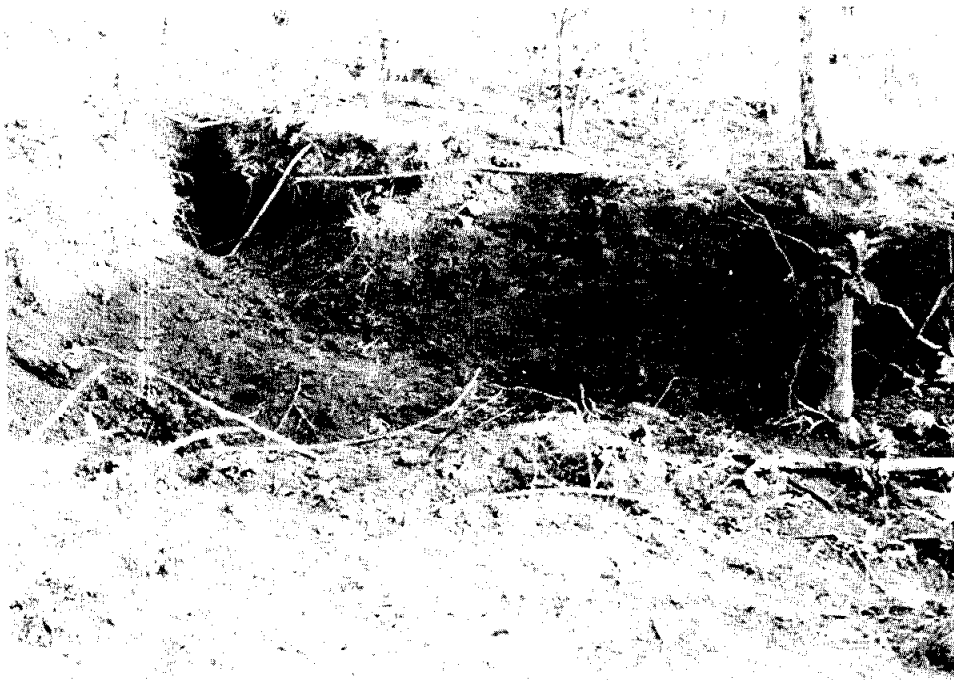
E-6 Crater Damage

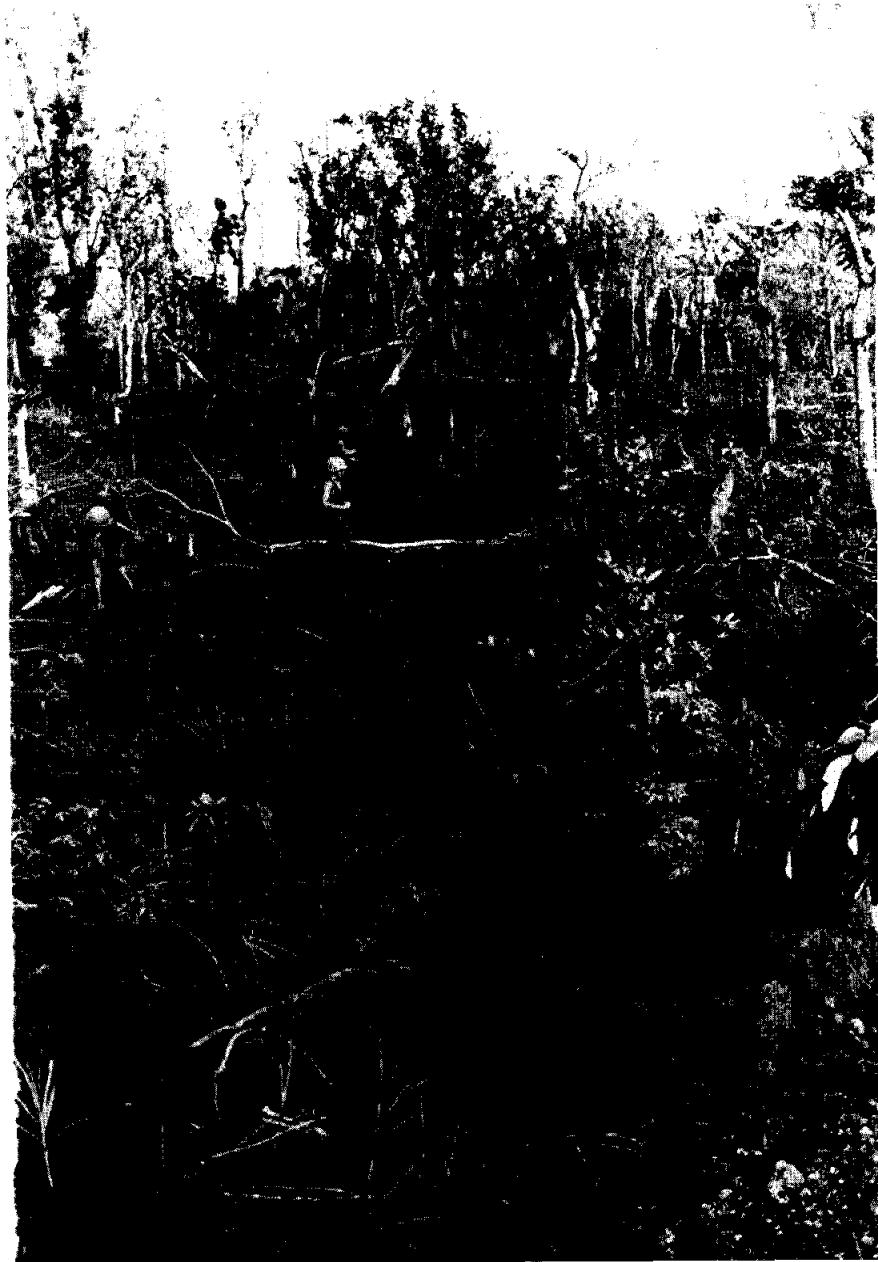
E-8 Damage to Living Area

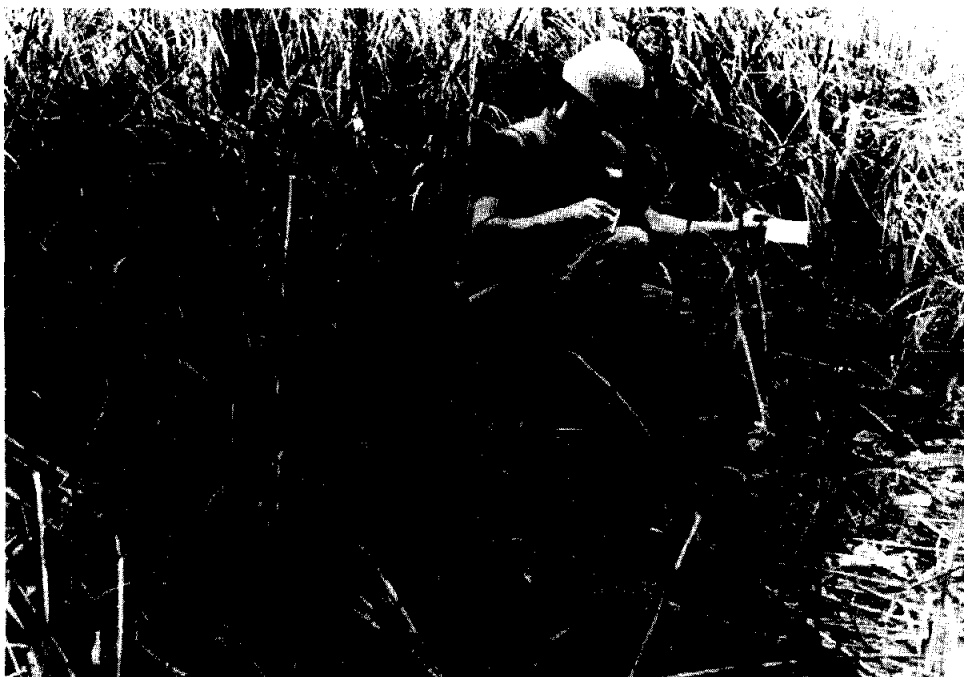
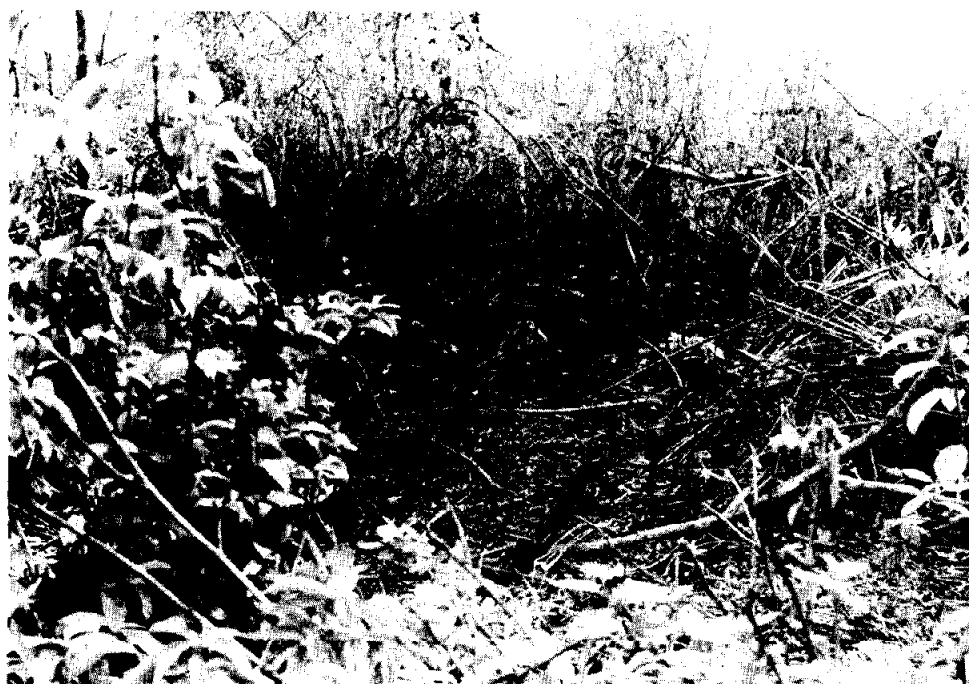
DESCRIPTION: Damage to grass and heavy brush by single  
tank of napalm. Diameter of burned area -  
20 meters.

H-1 Napalm Damage in Elephant Grass

H-2 Napalm Damage in Brush

a. There was a tendency to overestimate the effects of napalm as a method of burning off dense elephant grass. It was found that only the area within a 50 foot diameter of the point of impact was sufficiently burned to provide tactical fields of fire, or observation of the ground. In uphill terrain the splashing was retarded and in areas where the terrain sloped away from the aircraft heading, the tendency was to overshoot the desired point of impact. In most cases the grass beyond the 50 foot circle was blackened only at the roots, while the tops remained green. Heavy early morning fog and occasional light rain kept most of the foliage damp which lessened the effects of the napalm.
